# REPAIRING ASPHALT PAVEMENT

WORK DONE FOR THE CITY OF CHICAGO  
UNDER CONTRACT IN 1911

A REPORT PREPARED BY THE  
CHICAGO BUREAU OF PUBLIC EFFICIENCY

OCTOBER, 1911

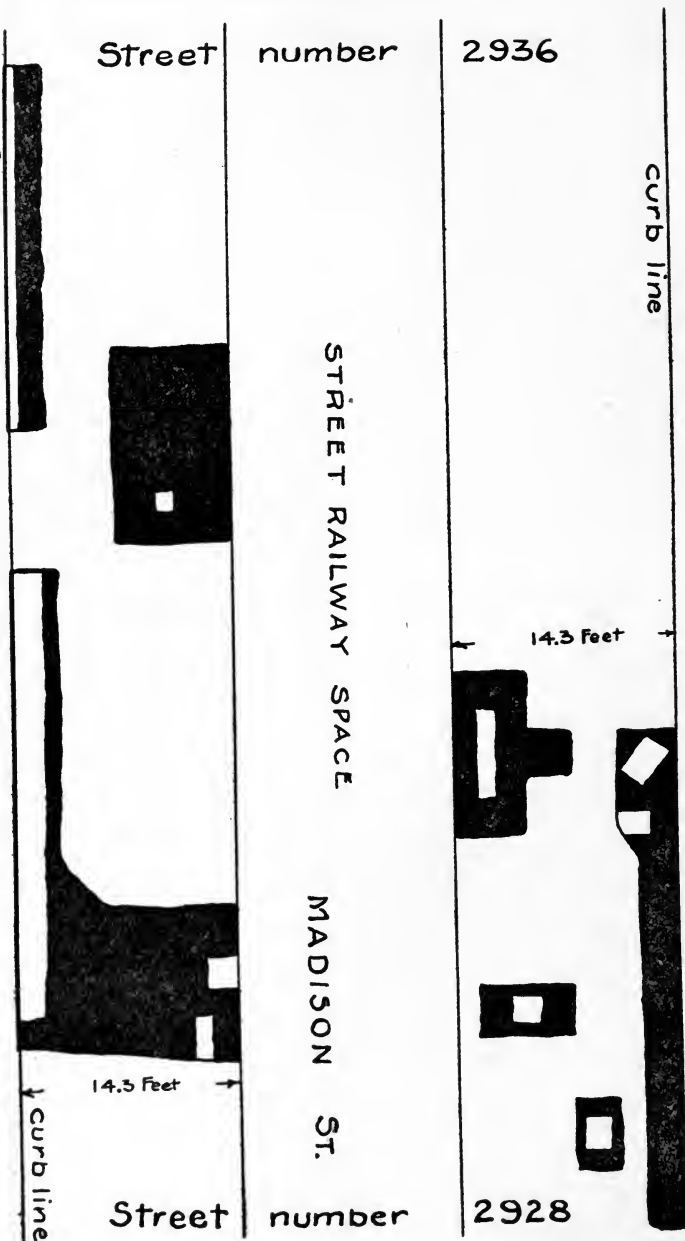
Specific instances were noted by Bureau investigators, at the time of repairing Madison street and Clark street, in which the cutting out of the asphalt pavement extended from 6 inches

Fig. 1. The small white spaces surrounded by black in the above sketch represent the areas which should have been repaired as estimated by the engineers of the Chicago Bureau of Public Efficiency. The black portions represent the excess of pavement actually repaired.

to 2 feet beyond the lines laid down by the inspector of the city.

Another instance was a series of repairs extending about 3 feet from the curb, with stretches of good pavement between the patches, in which the contractor removed the good pavement, even though it was not marked, and for no obvious reason.

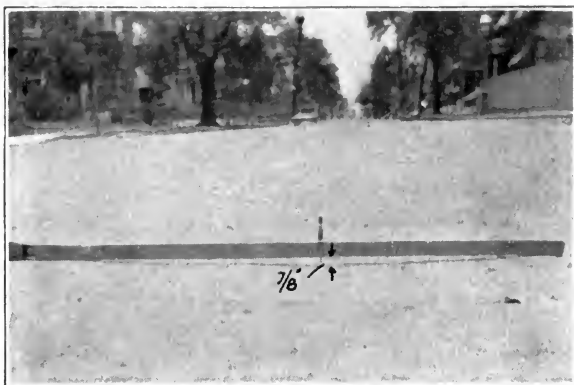
**Fig. 2.** Prairie Avenue south of Twenty-ninth Street. A 42-inch straight edge laid across the area repaired showed the entire area to be lower than the adjacent pavement. At the center (indicated by arrows) it was  $\frac{7}{8}$  of an inch low.

There are some new repairs where practically the entire area is below the surrounding pavement. In one patch about  $3\frac{1}{2}$  feet square there is a depression of  $\frac{7}{8}$  of an inch. A repair area  $10\frac{1}{2}$  feet long and  $4\frac{1}{2}$  feet wide contained two depressions of 3 square feet each, in which water was standing to the depth of  $\frac{3}{8}$  of an inch. Another repair, 16 feet by 5 feet, had two depressions of 3 square feet each, containing water to a depth of  $\frac{1}{4}$  of an inch.

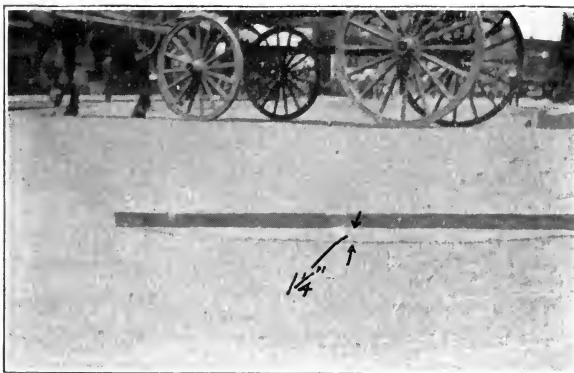
**Fig. 3.** Clark Street at the intersection with Illinois Street. The binder course on this repair was laid cold and allowed the material to roll which resulted in part of the area being left lower than that adjacent to it. A straight edge laid across the depression showed it to be  $1\frac{1}{4}$  inches deep at the center (indicated by arrows).

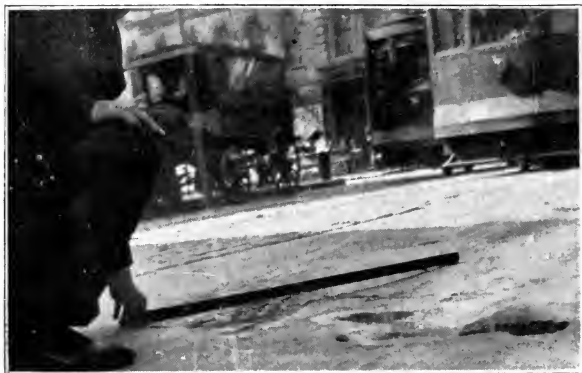
**Fig. 4.** Clark Street between Michigan and Illinois Streets. This repair was made on June 17, 1911, and the photo taken on July 24—five weeks later. The binder was laid in wet weather and, being defective, did not afford sufficient foundation for the wearing surface, which soon worked forward and left the concrete base exposed. (See area beneath and to the right of the straight edge.)

Lack of inspection is responsible for the wearing surface of a thickness less than  $1\frac{1}{2}$  inches, as required by the specifications. Measurements were made where it was only  $\frac{1}{2}$  inch. It is also responsible for the rolling of the wearing surface, as can be seen on North Clark street, at which point depressions of  $1\frac{1}{2}$  inches are formed, even though this repair has been in use but five weeks.

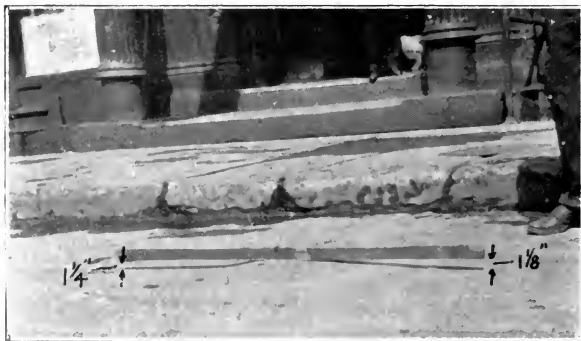
On June 16 a load of binder was unloaded and distributed during a rainstorm, the foreman and inspector standing under an umbrella while the work was being done. When the binder was tamped, water came to the top through the material.

**Fig. 5.** Clark Street between Michigan and Kinzie Streets. The above figure shows another result of binder being laid in wet weather. In this case the surface has worked up to the center of the repaired area, causing a depression on either side. A straight edge laid horizontally across the center showed the depressions to be  $1\frac{1}{4}$  and  $1\frac{1}{8}$  inches in depth (the depth is indicated by arrows).
